Lake Bennett
Dam Inspection Report
Photographic Documentation
March 4, 2020

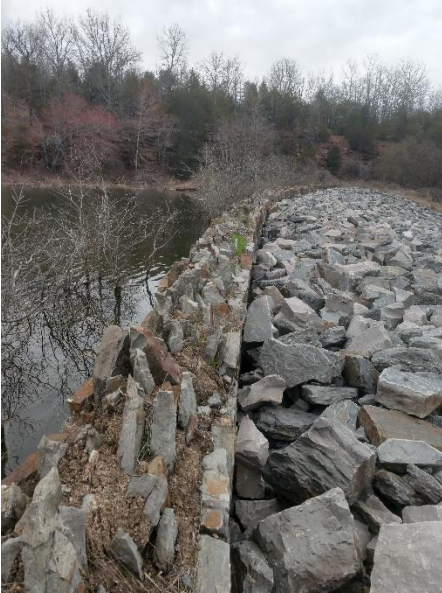
1. CREST OF FILL

Looking East

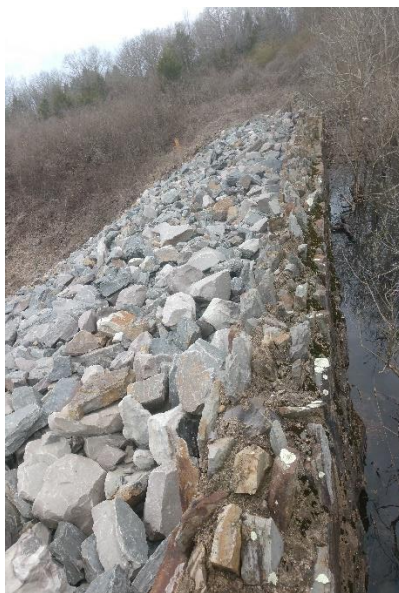
Looking West

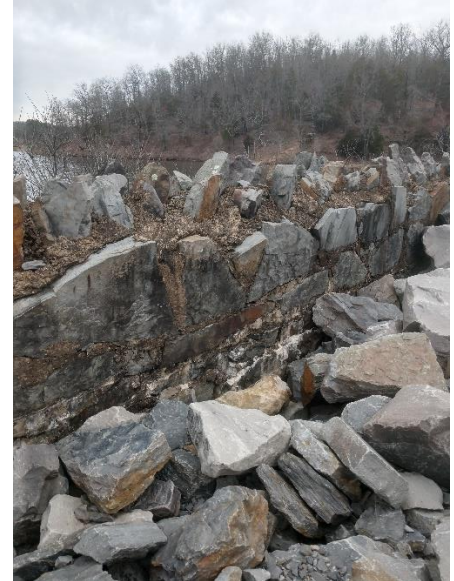
Crest of Rock Center

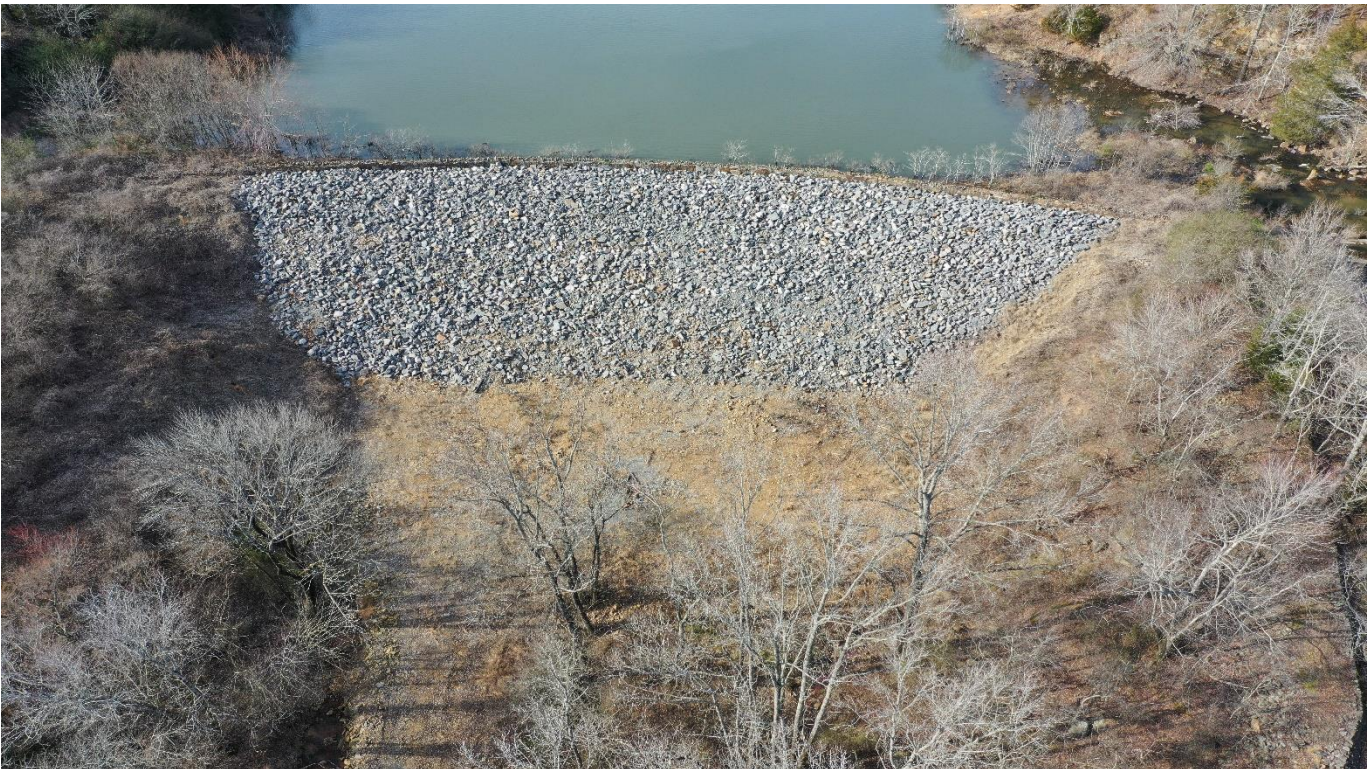
Crest facing upstream

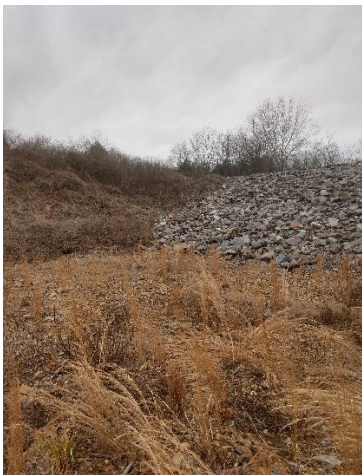
4. ABUTMENT CONTACTS

Left

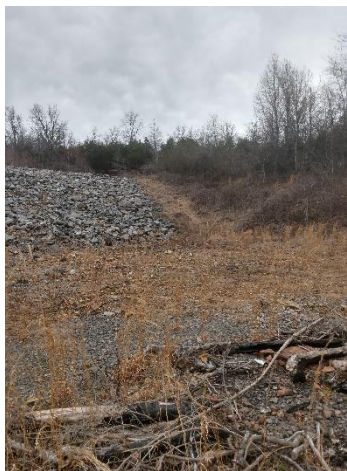
Right

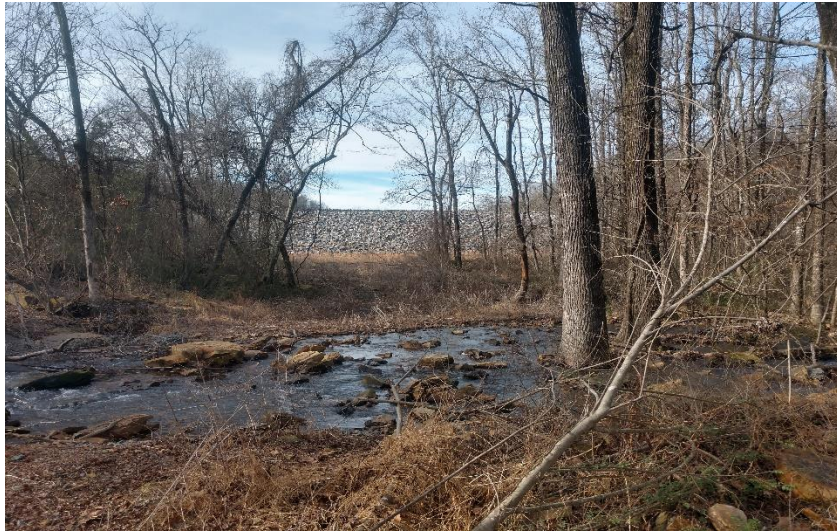
8. PLUNGE BASIN

There is no constructed plunge basin for structure. Outlet is into original stream.

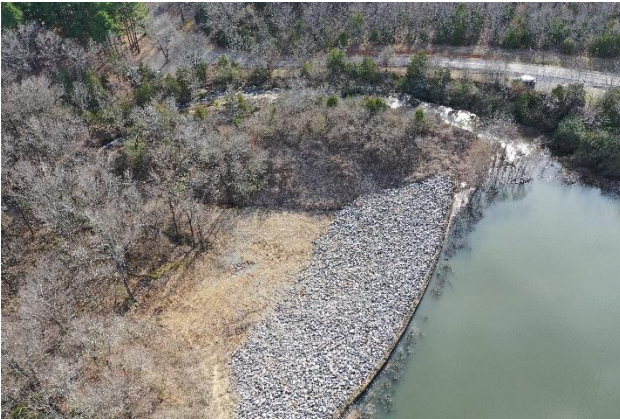
9. EXCAVATED ROCK SPILLWAY

Left Spillway

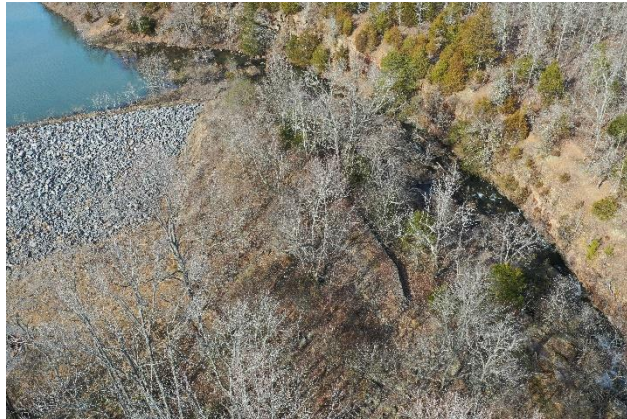
Right Spillway

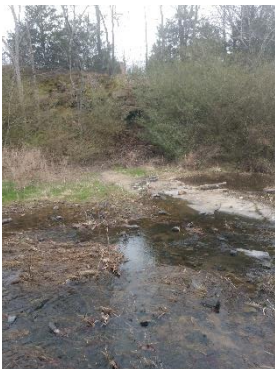
Left looking down

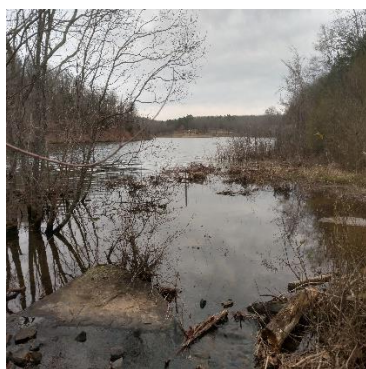
Left looking up

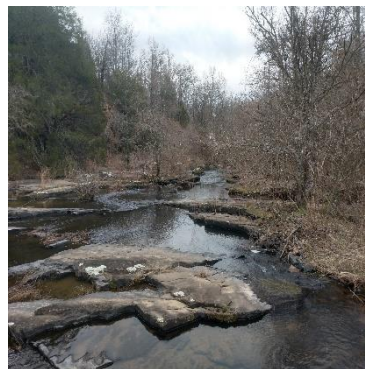
Right looking down

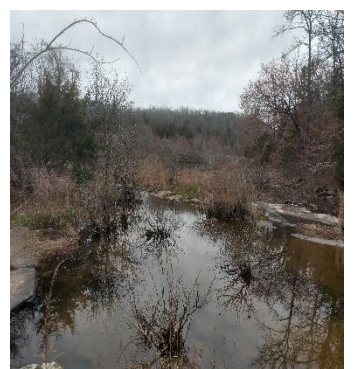
Right looking up

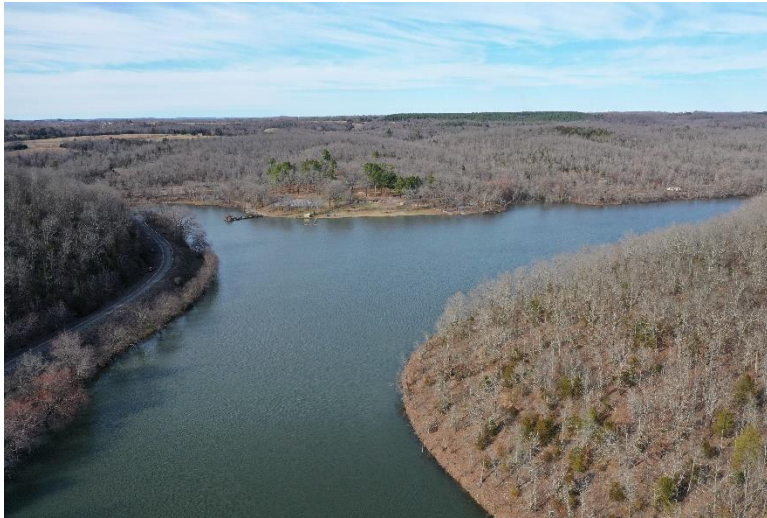
12. RESERVOIR CONTROL

Photo taken above centerline of dam facing upstream. State Park beach is visible.

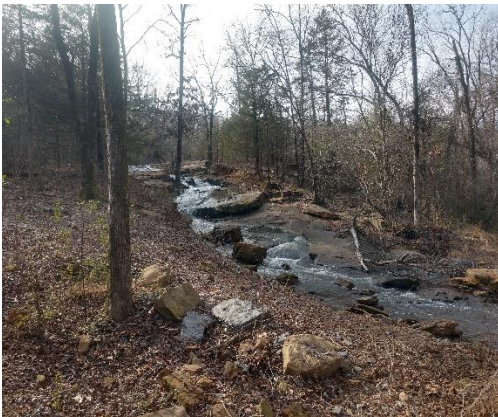
13. OUTLET CHANNEL

Left outlet

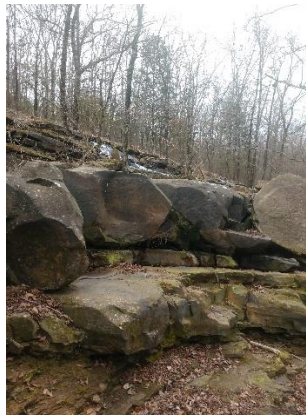
Right outlet

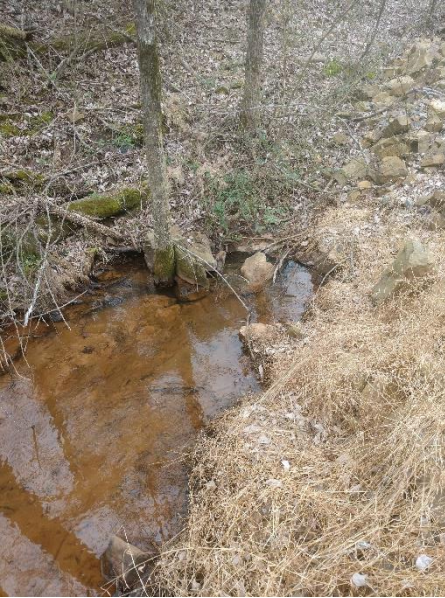
15. AREA BELOW DAM

100' Downstream Lt. Side

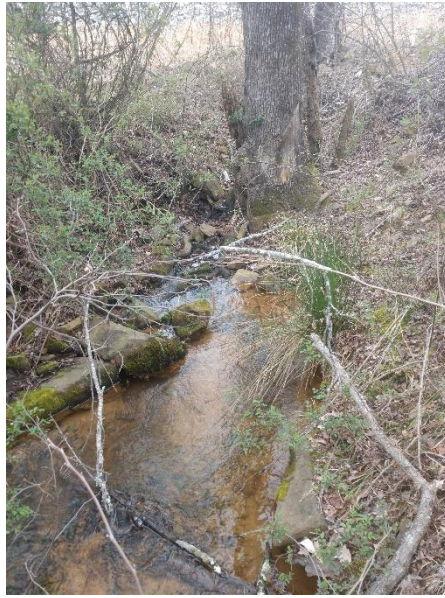
100' Downstream CL

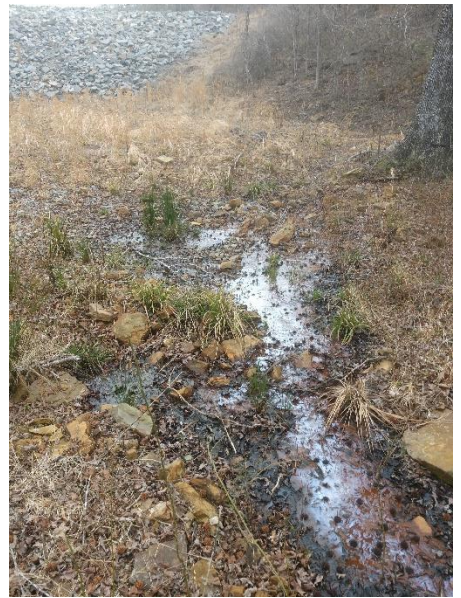
100' Downstream Rt. Side
