# EWP Channel Bank Stabilization Cane Island Branch and Willow Fork of Buffalo Bayou For Fort Bend County Drainage District

## **PROJECT DESCRIPTION**

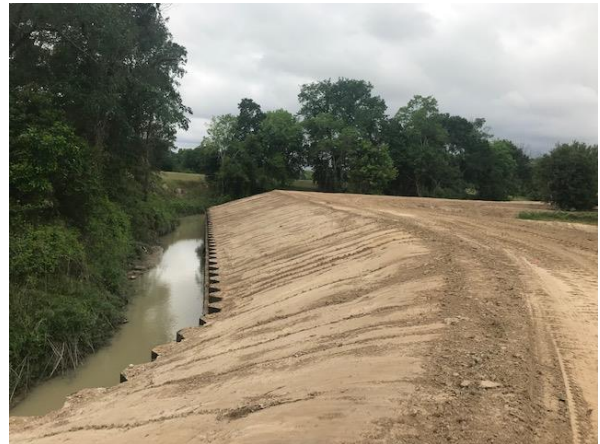
**Phase 2 – Completed pre-vegetation**

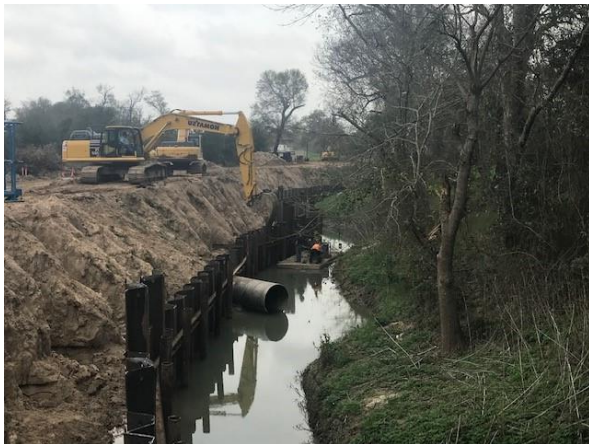
**Phase 2- Waler installation**

3) Structural design. This repair consists of constructing steel sheet pile walls along the channel bottom. The walls will consist of Z shaped sheet piles supported with a walers and helical anchors. Wall heights will vary to best match the height and channel slope above the wall to fit within the established easement held by the FBCDD. The design software Pile Buck (SPW911, v2.40) and HeliCAP (v2.5.1) were used to design the sheet piling and helical anchors respectively. Placing rock riprap on both the beginning and ending of each sheet pile wall site will insure flow transition without scour on either side of the steel sheet pile wall.

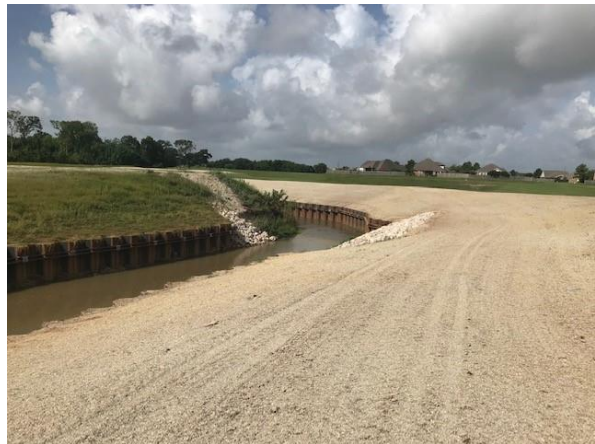
**Phase 3 – Completed pre-vegetation**

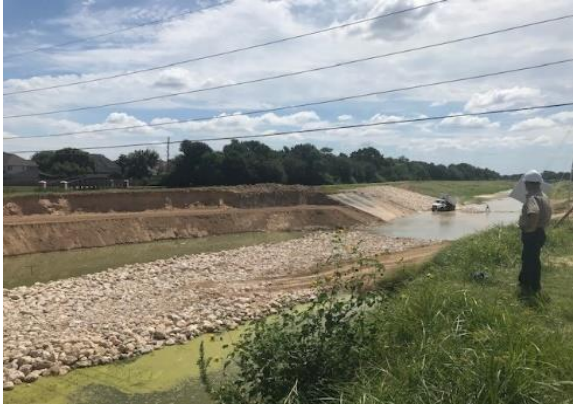
**Phase 6 – Site 316 Rock Riprap**

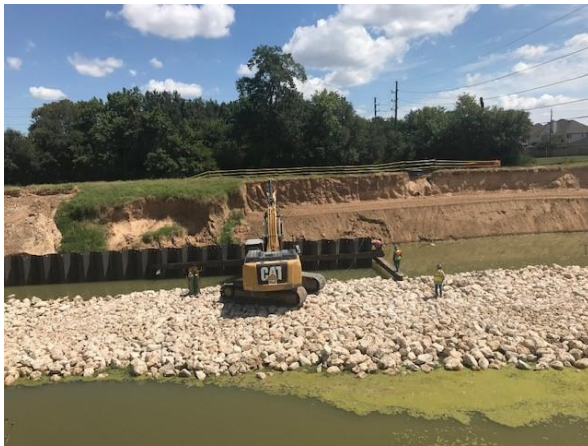
**Phase 6 – Site 316 Pinning Sheet Piles**

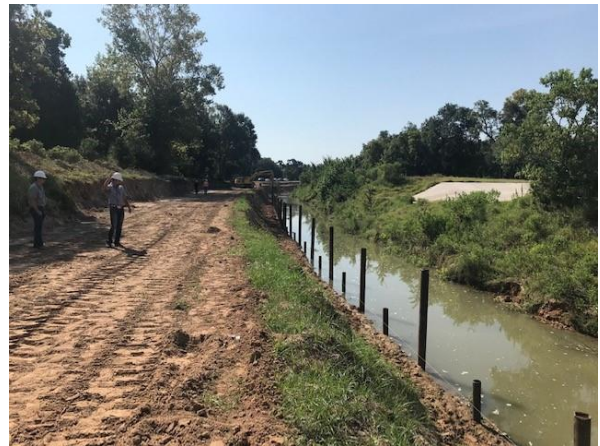
**Phase 4 – Setting alignment piles for wall**

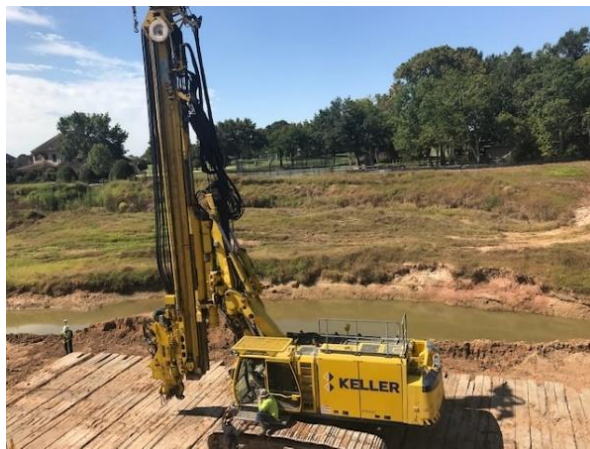
**Phase 5- ABI Sheet pipe driver**
